FINAL REPORT for GOS 2021 Bill Terrell Avian Conservation Grant titled “Restoring Shell Rake Habitat for American Oystercatcher”

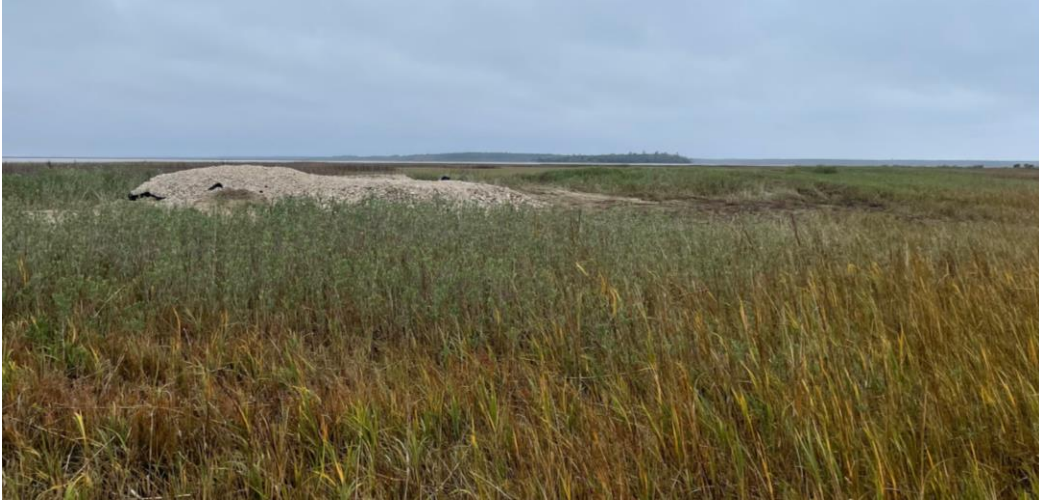
Completed Rake on Satilla Marsh Island East.

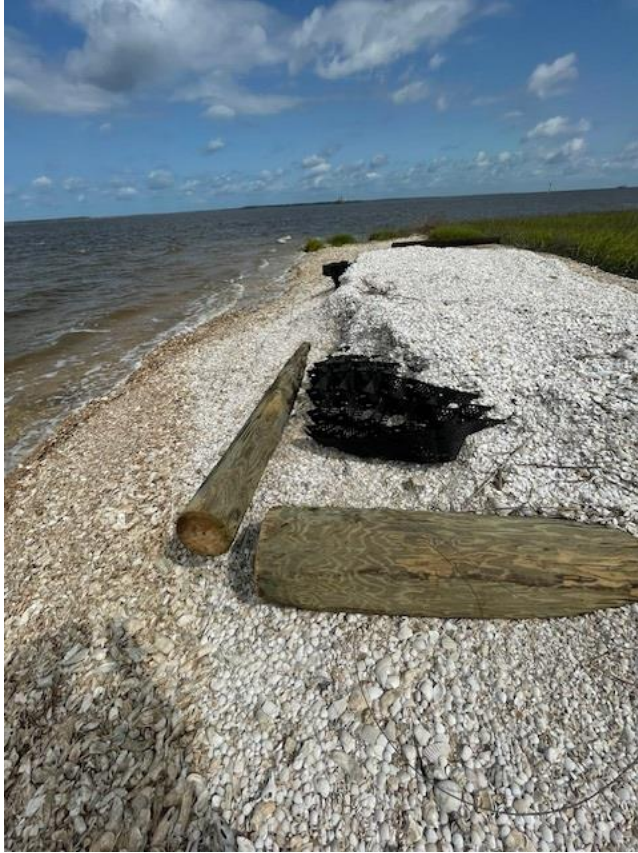
One of our sites (which still produced an AMOY chick) ended up being damaged by a prolonged storm which exposed it to 4-5 days of steady southerly winds and waves. The anchors that were used to hold the logs in place did not keep several of the logs from floating and pulling the cables up. This allowed for some of the shell to be washed away exposing some of the geocell fabric covering the project. Fortunately, the nest was not disturbed and the pair continued to use the site. There was a risk at one point of small chicks getting trapped in the geocell, so some of the exposed material was cut and removed. We chose to delay major renovations until the pair had completed nesting so as not to disturb the pair.

Damage on Stafford North following hurricane season. This site will be rehabbed during the winter of 2025.

We are currently working with the contractor to plan a renovation of the site. There are several options we can try, including using alternate anchoring techniques (possible under our current permit) or using a completely different material to support the shell rake such as Flexamat concrete fabric (requiring a new permit). High water coupled with wave action appears to have floated the logs, pulling the anchors loose. Concrete, or some other dense material that is less prone to floating may survive longer, especially in sites where the substrate is soft enough that duck-bill anchors are not effective.

Maintenance: There is a reasonable expectation that all platforms will require some maintenance following hurricane season and winter storm season. Any platform construction should plan on a mid-winter rehab visit to make sure all the platforms are in good working order. We currently have funds to visit and repair these 5 platforms in January or February of next year in preparation of the 2025 AMOY nesting season. We also plan to submit a grant request for more funds to continue to expand this project.
